Manhole Inspection Summary

Manhole # S33Q__068MH

Insp Date: **2/5/08 2:51 PM**

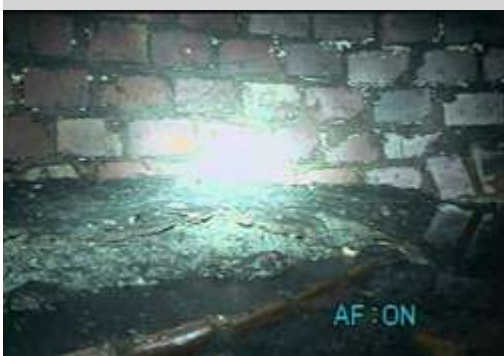
Defect 1

Bench ☒ Exists Material: **Brick** ☐ Parged
Condition: ☐ Sound ☐ Cracked ☐ Root Intrusion ☐ Deteriorated ☐ Leaks ☒ Debris

bench debris

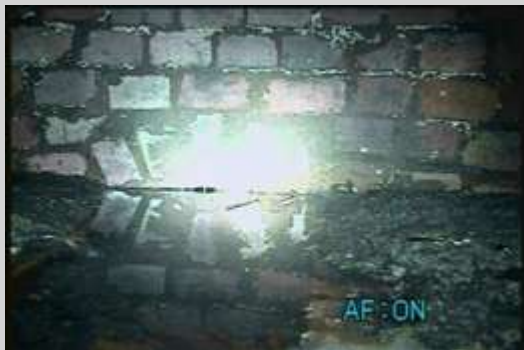
12 O'Clock Outflow

8 in. Circular Gravity Sewer
Pipe Out @ 12 O'Clock

Deposits: ☐ None ☒ Mud ☒ Gravy ☒ Debris ☐ Grease

Silt Depth: 8 (in.) Deposits Extent: Heavy

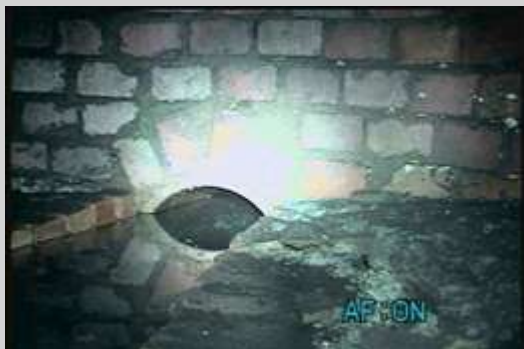
7 O'Clock Inflow

8 in. Circular Gravity Sewer
Pipe In @ 7 O'Clock

Invert Depth: 8.90 (ft.) Flow Characteristics: Slow

Deposits: ☐ None ☒ Mud ☒ Gravy ☒ Debris ☐ Grease

Silt Depth: 6 (in.) Deposits Extent: Heavy
